CONCRETE CLOTH™

SLOPE PROTECTION

21.12.10 Case Study : Alcobendas Station, Madrid, Spain

Concrete Cloth Slope Protection

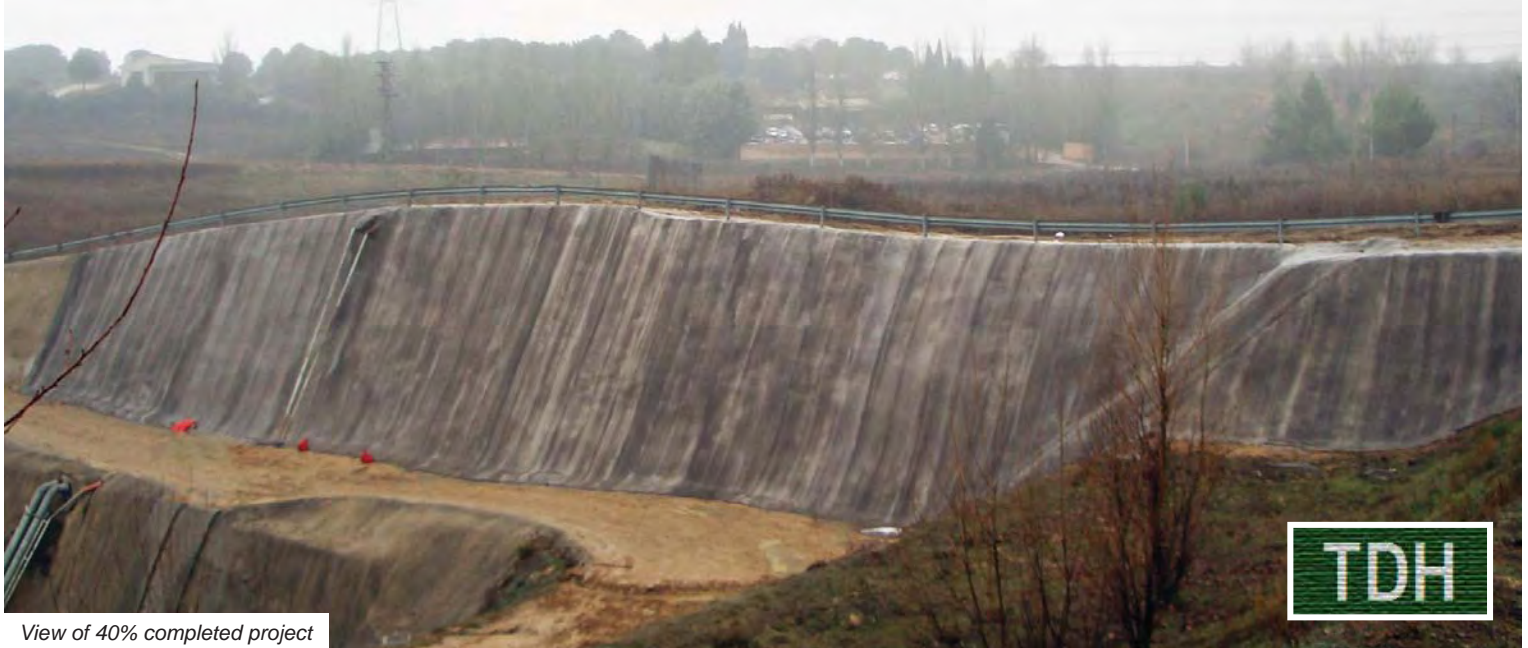
View of 40% completed project

CC8 was specified and 2500sqm of material was delivered on site in bulk rolls. The project's first phase of 800sqm was completed in under 3 days and was 70% quicker to install than if shotcrete had been used.

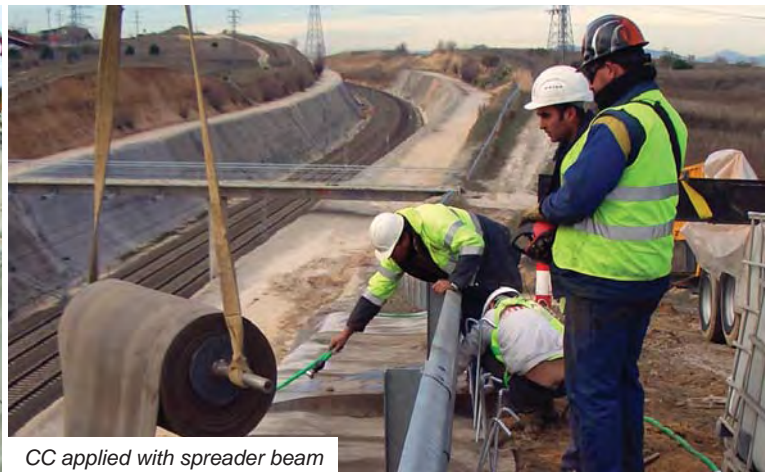
CC applied with spreader beam

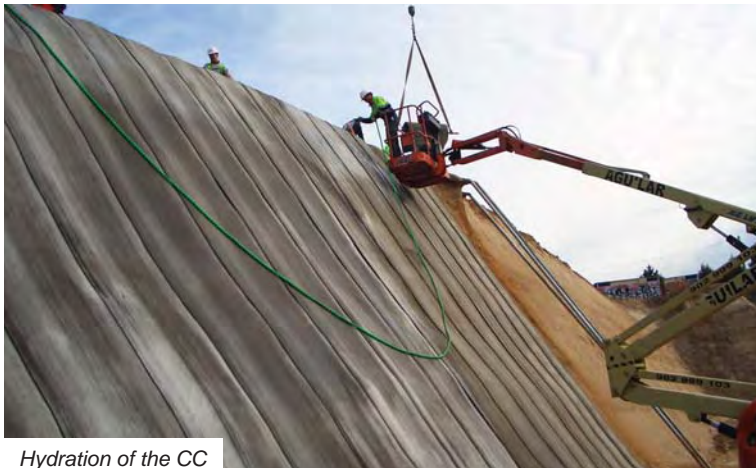
Hydration of the CC

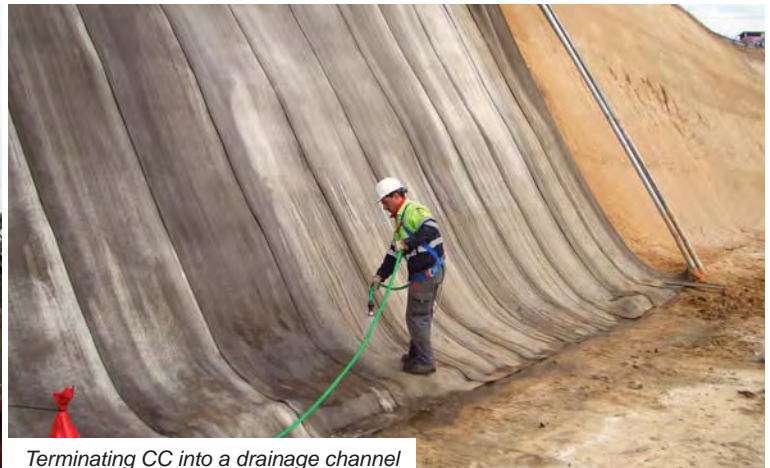
Terminating CC into a drainage channel

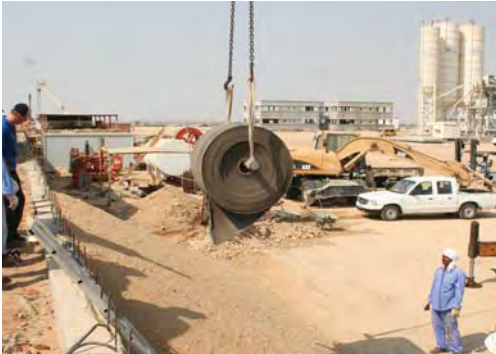
CC4 or CC8 in rolls of 200sqm or 125sqm respectively can be handled & positioned using site plant.

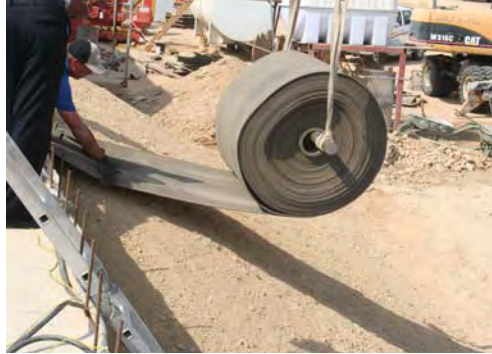
CC is rolled from the slope crest down the slope face, with 100mm overlaps between adjacent CC sheets.

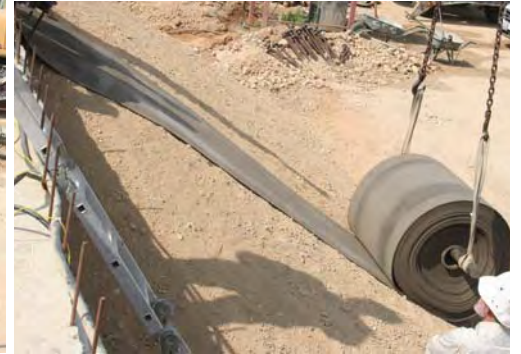
CC is cut to length, depending on the slope size.

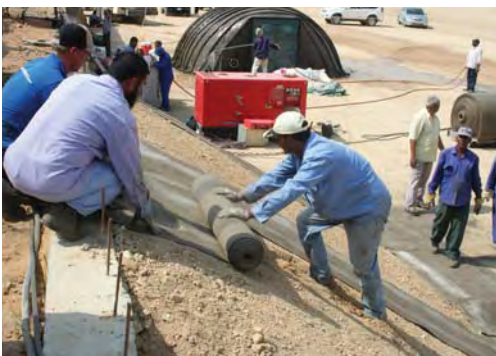
Short lengths of CC can be provided in man portable lengths for manual application.

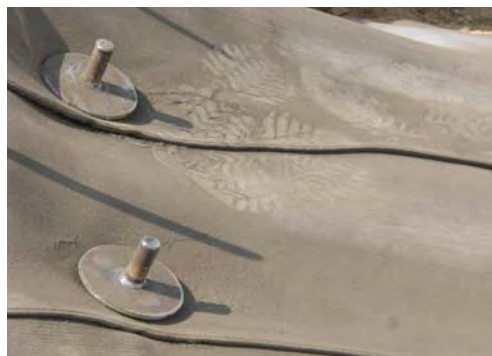
CC is fixed using short nails hammered into the soil. Other fixing methods such as drilled bolts can also be used if rock is present.

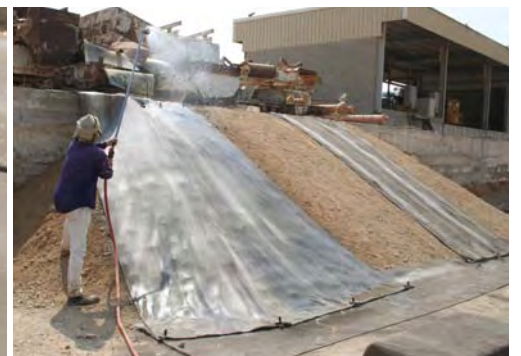
CC is hydrated once fixed into position. Lined drains can be formed from CC at the slope crest and toe.

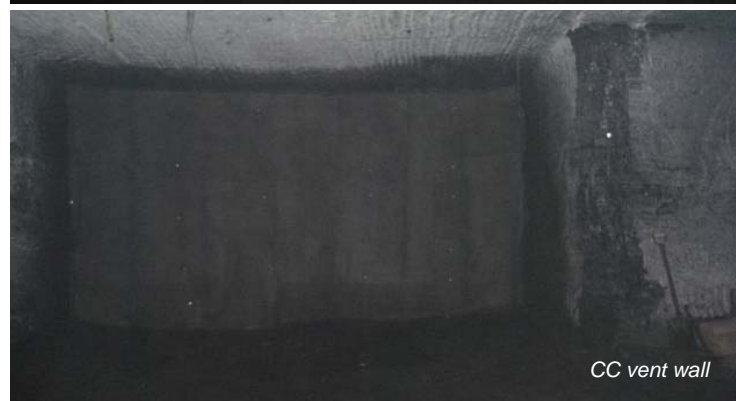
The two images to the right show a successful CC vent wall trial conducted in the Gloria Mine in Mpumalanga for Optimum Coal Mining, via our South African distributor, Concrete Canvas SA in November 2010.

CC vent wall

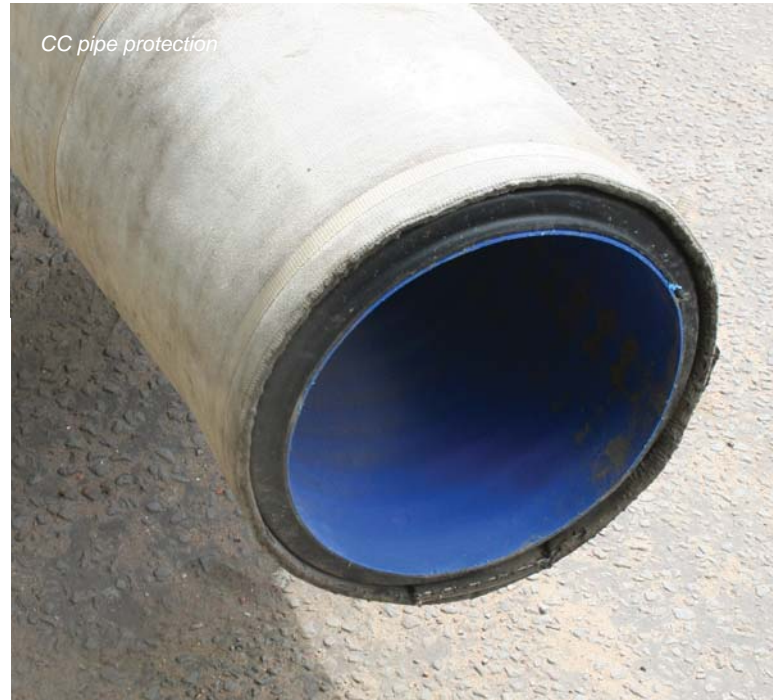
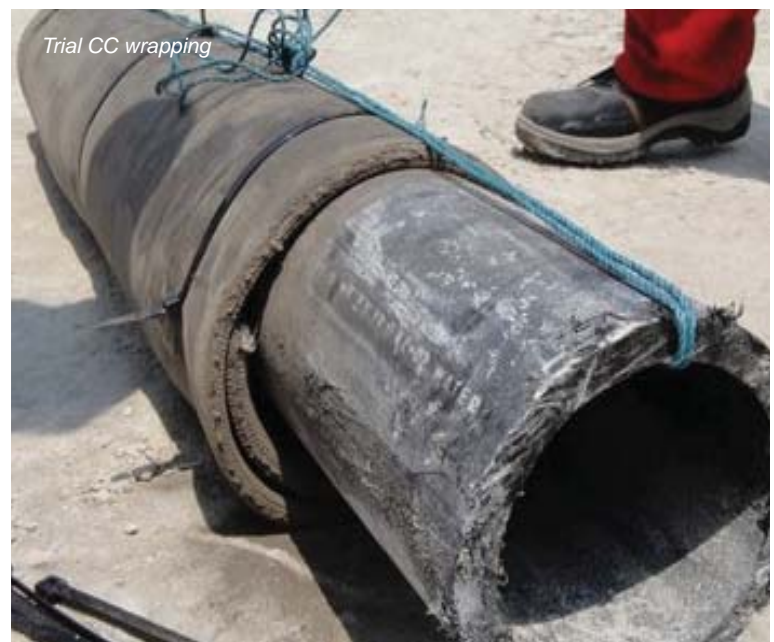
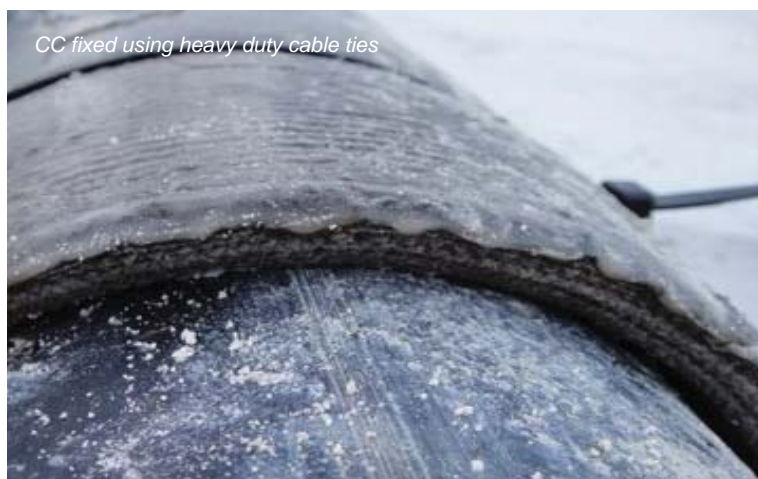
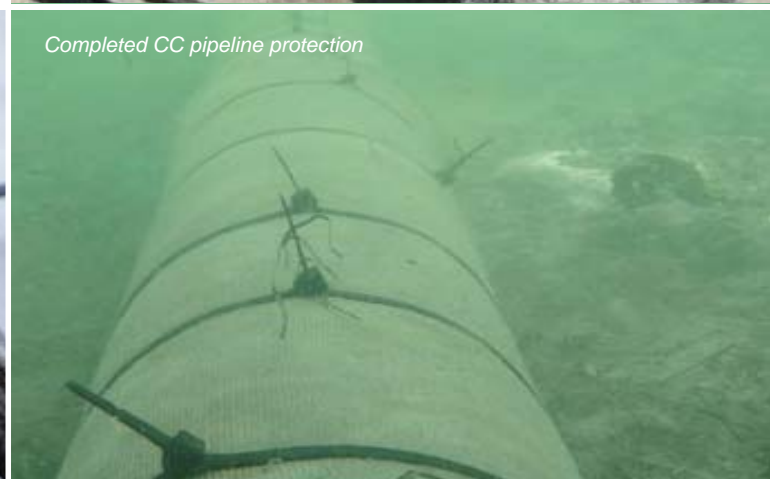
The CC was installed in-situ at a depth of 5m below tidal waters. Divers were able to line approximately 60m of pipeline per day. The CC was cut into sections on site which were latitudinally wrapped around the pipe and fixed in position using heavy duty cable ties. CC can be hydrated using seawater, so the Cloth set underwater providing a durable and impact resistant protection.

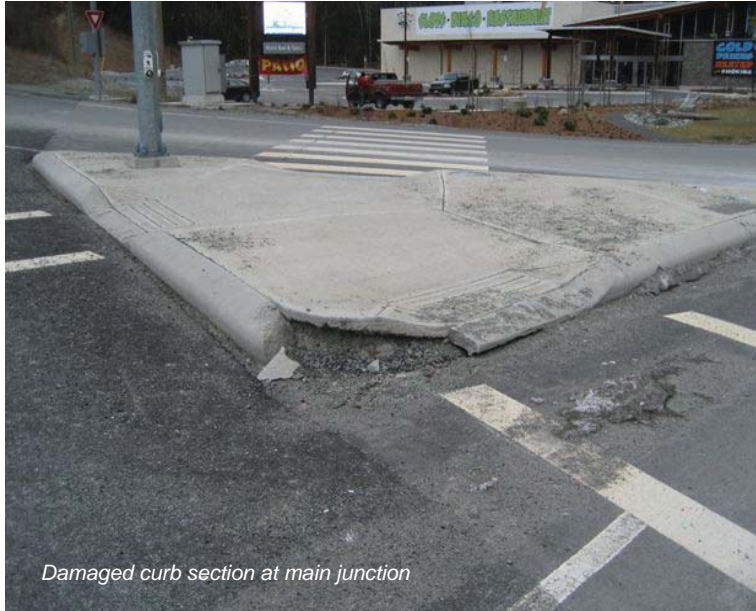
Damaged curb section at main junction

In January 2011, Miller Capilano Highway Services were commissioned via our Canadian distributor, Nuna Innovations, to trial the use of Concrete Cloth (CC) to repair damaged curbs. The void in the curb was first filled and then lined with CC8. The CC was wrapped around the curb and fixed into position using standard concrete anchor screws before hydrating. Following the success of the trial, which was completed in under two hours, a number of other curb sites are being considered for refurbishment using CC.

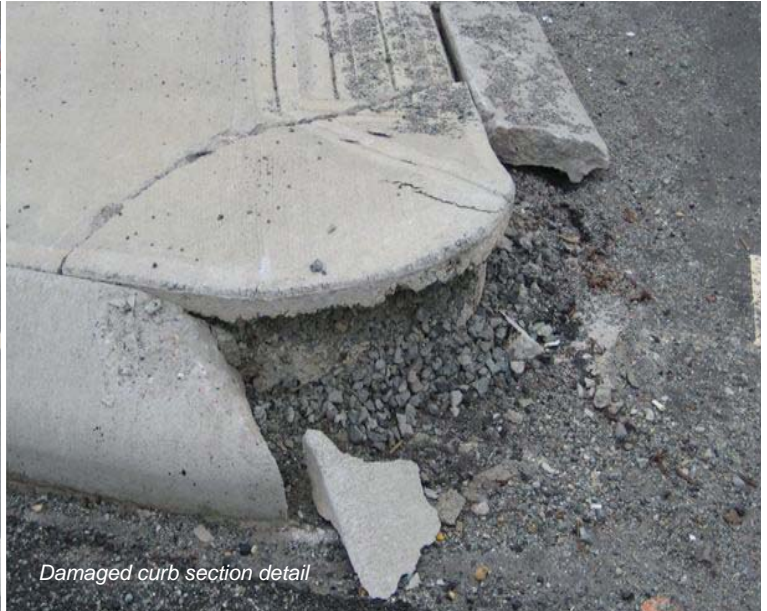
Damaged curb section detail

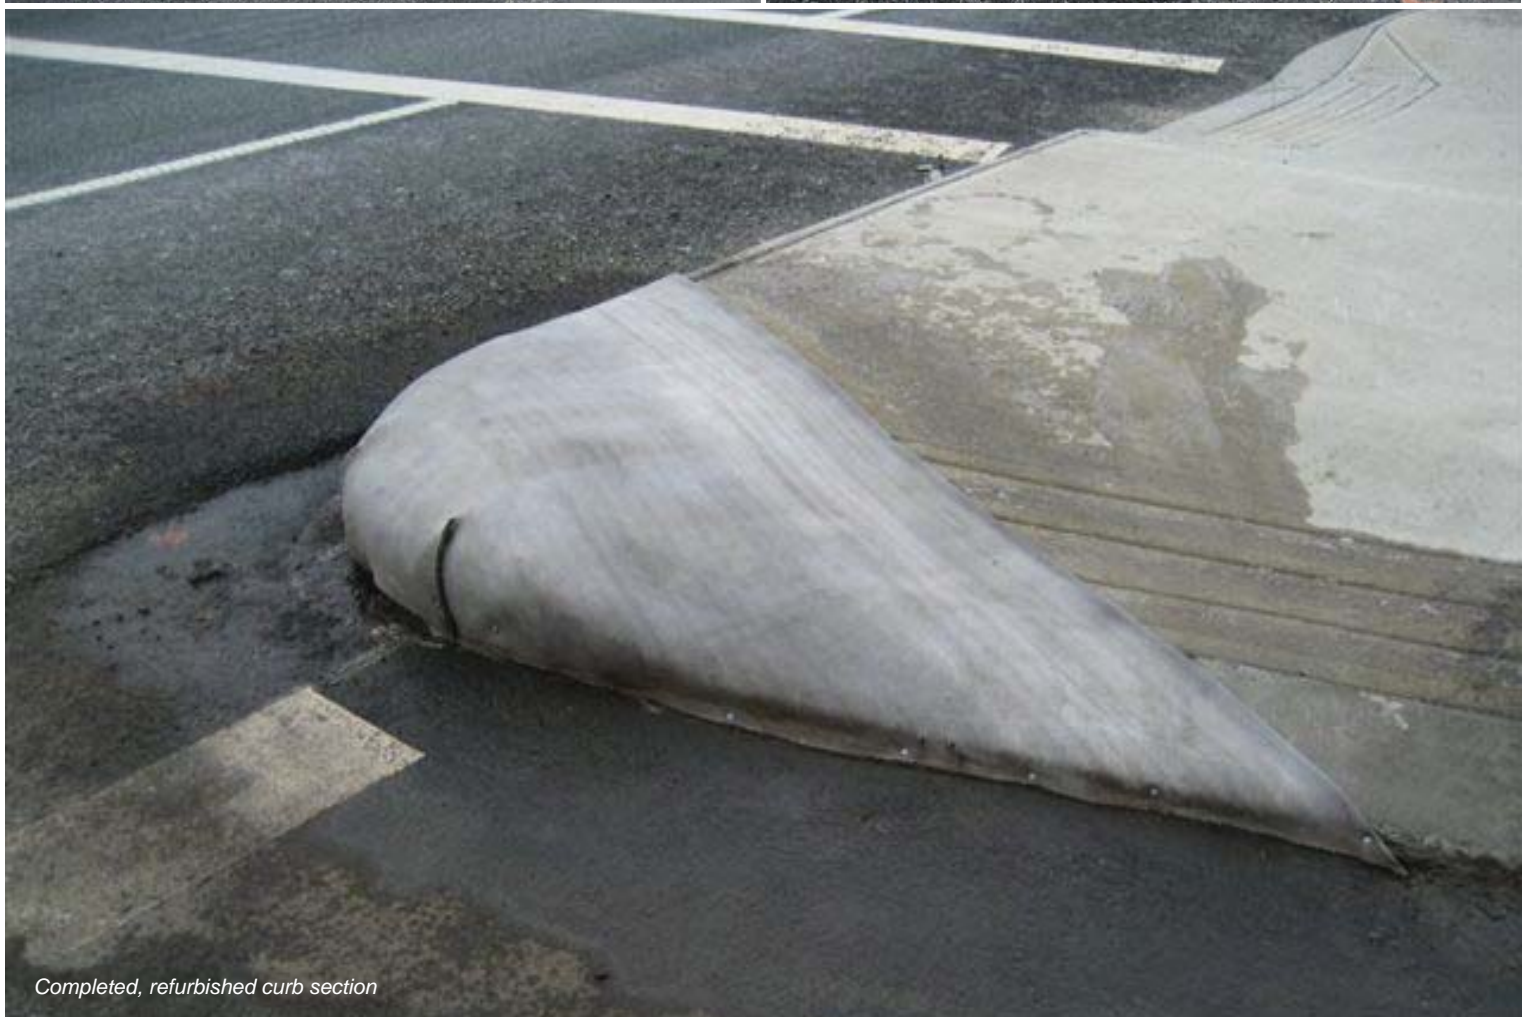
Completed, refurbished curb section

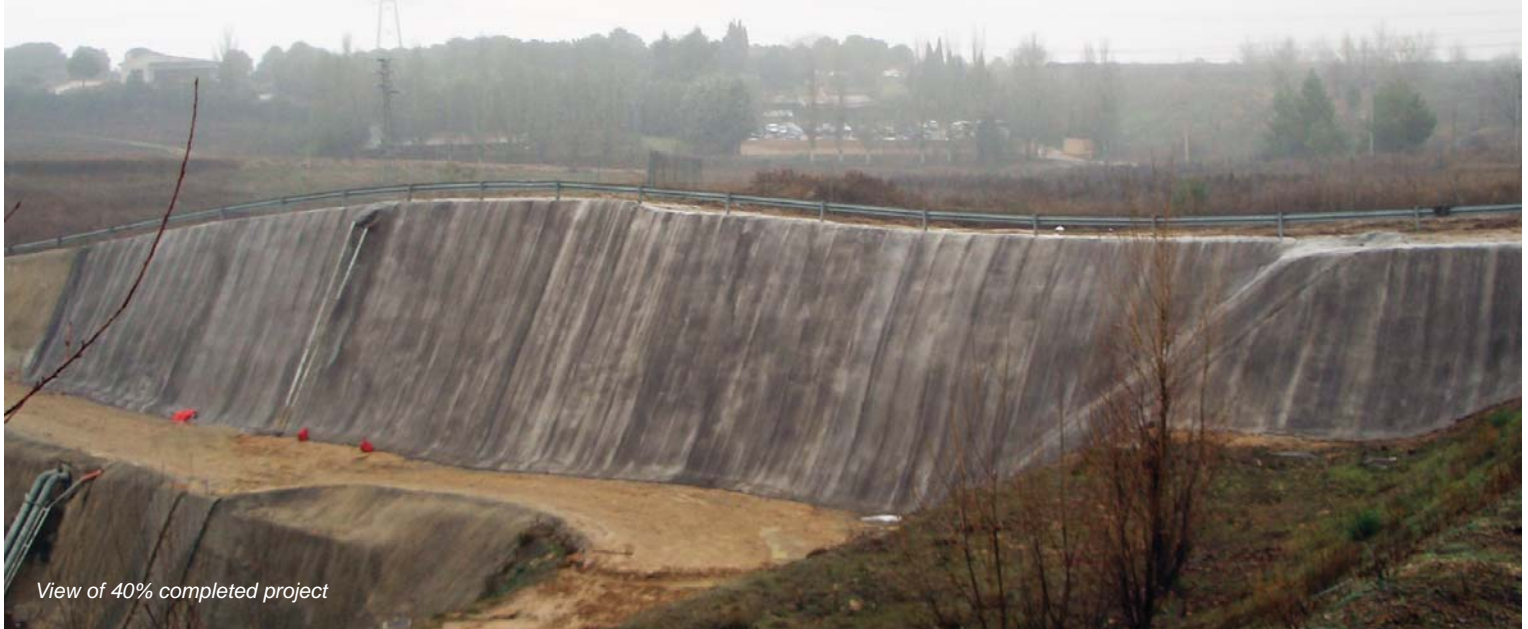
View of 40% completed project

CC8 was specified and 2500sqm of material was delivered on site in bulk rolls. Using a crane mounted with a spreader beam to position the CC, the project's first phase of 800sqm in under 3 days.

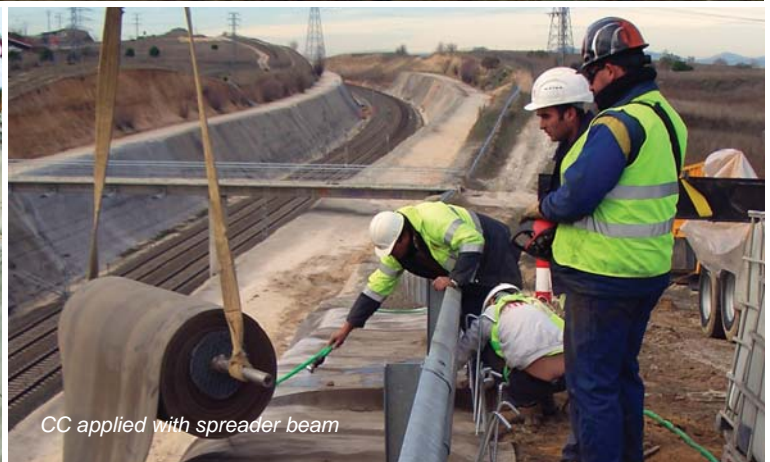
CC applied with spreader beam

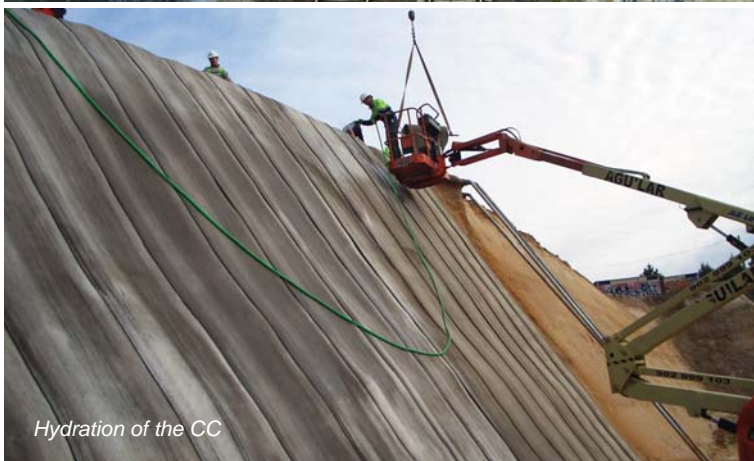
Hydration of the CC

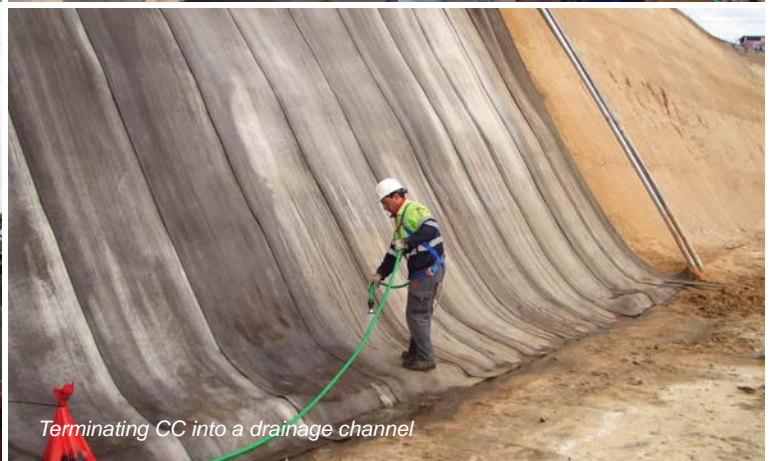
Terminating CC into a drainage channel
